**National Highway
Traffic Safety
Administration**

Case Vehicle (A): 1999 Pontiac
 Type: Grand Am, 2-door coupe
 Driver: 28-year-old male
 CDC: 12-FREN-5, 12-LDES-2

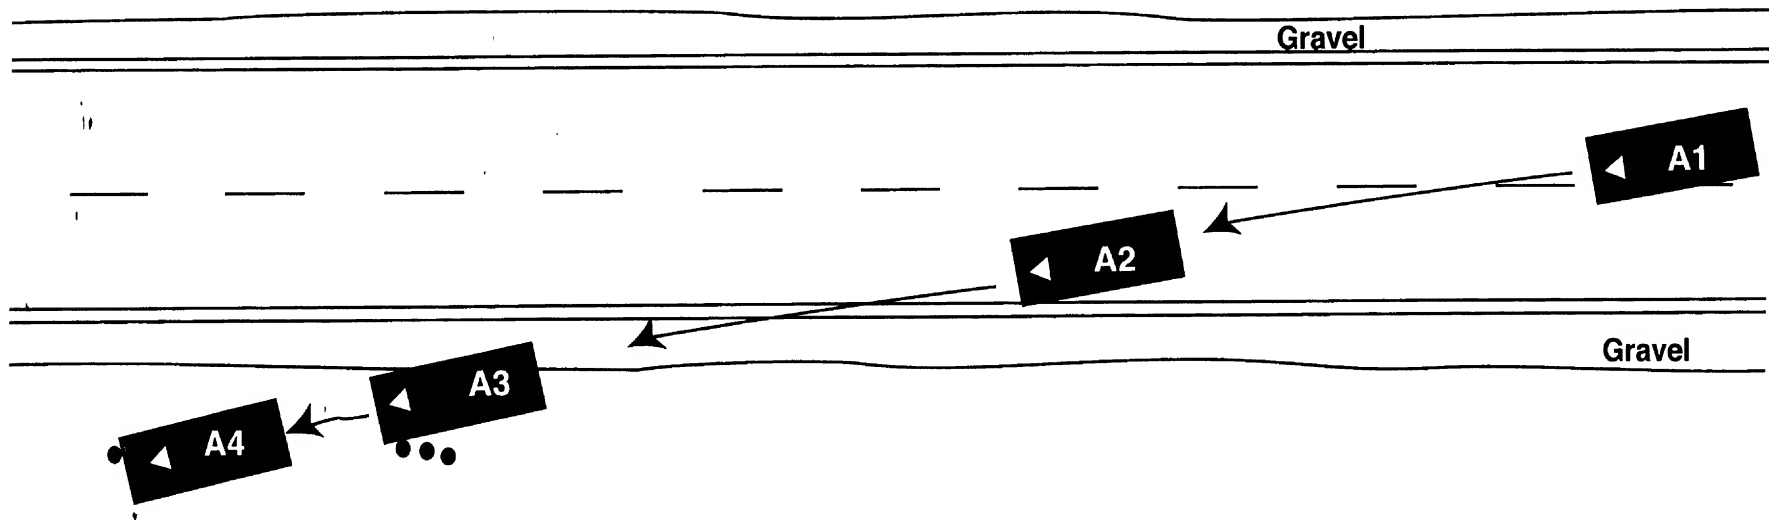
ACCIDENT SCHEMATIC

ACCIDENT DESCRIPTION: Case vehicle (A) was traveling south in the southbound lane of a 2-lane roadway. Case vehicle (A) drifted across the center line, departed the roadway, and traveled down a shallow embankment. The left side of Case vehicle (A) sideswiped a clump of trees before Case vehicle (A) struck a tree with its right-front bumper. Case vehicle (A) came to rest facing south-south east. The driver of Case vehicle (A) had a blood alcohol level of .16 percent

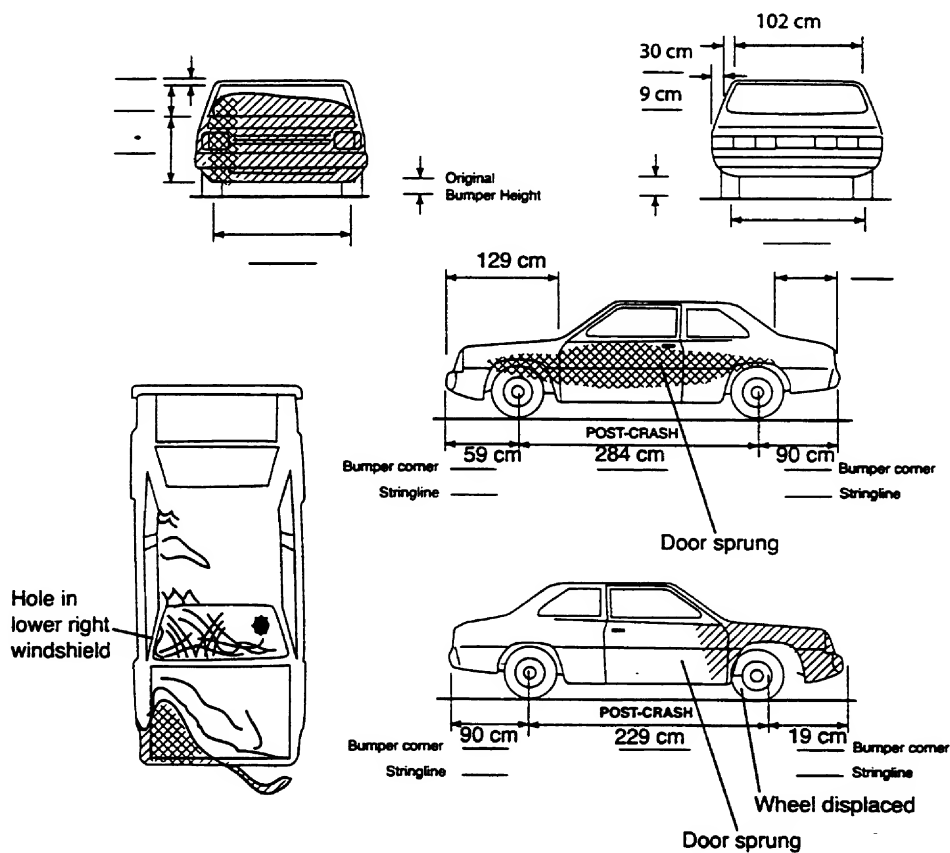
MEASUREMENTS IN CENTIMETERS

(Slide 4) Damage to case vehicle (A) was severe. The direct-damage length was 37 cm and began 10-cm in board of the right-front bumper corner. The maximum crush to the bumper was 116 cm and occurred at the right-front bumper corner. The left wheelbase was extended 13 cm, and the right wheelbase was reduced 42 cm. The maximum crush above the sill associated with the sideswipe impact was estimated to be 14 cm.

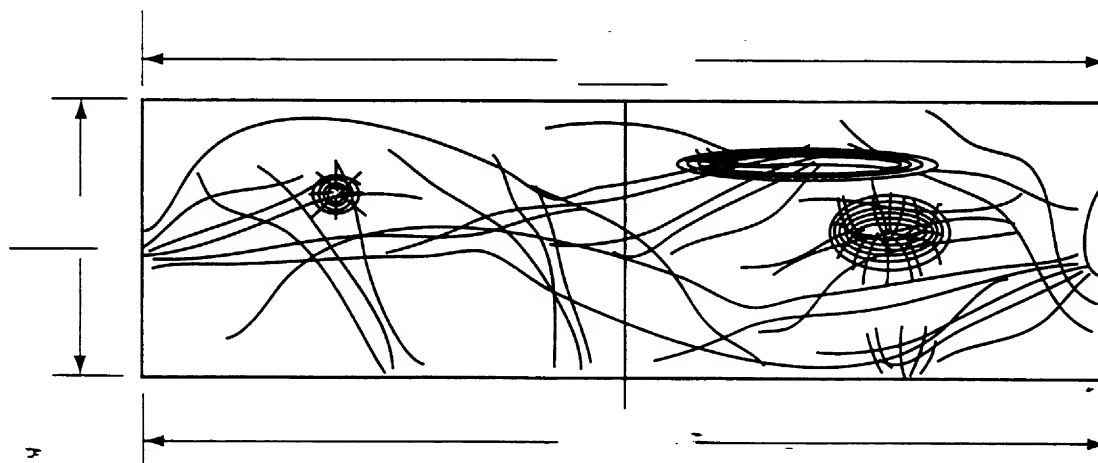
LOCATE AREA OF WINDSHIELD INTEREST OR DAMAGE WITH DIMENSIONS (VERTICAL
 & HORIZONTAL) ON THIS DIAGRAM OF THE WINDSHIELD AS VIEWED FROM INSIDE.

latch was jammed. Both hood hinges were damaged, but did not separate. The rear edge of the hood was elevated and it contacted the windshield, but did not penetrate it. (Slide 12) The windshield was holed from the bottom right corner up to approximately two-thirds the height of the right A-pillar. Both doors remained closed during the crash, but were sprung and would not close post-crash.

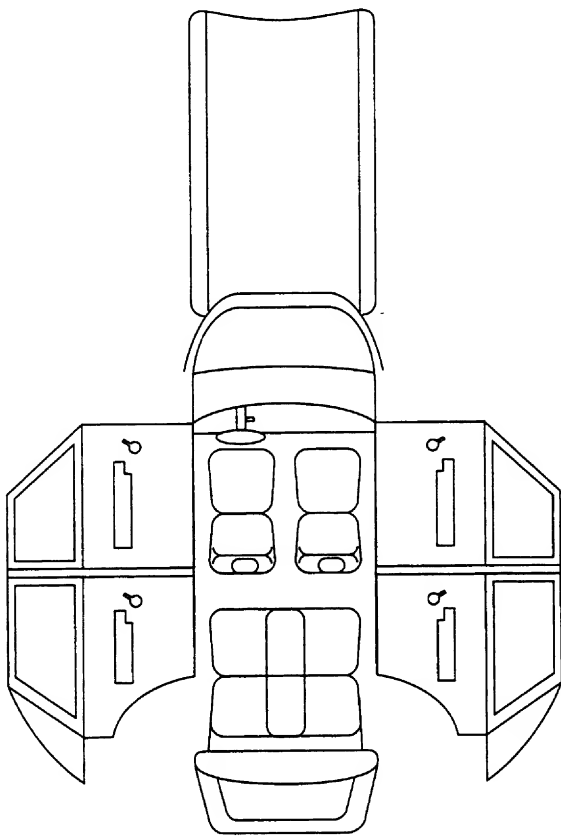
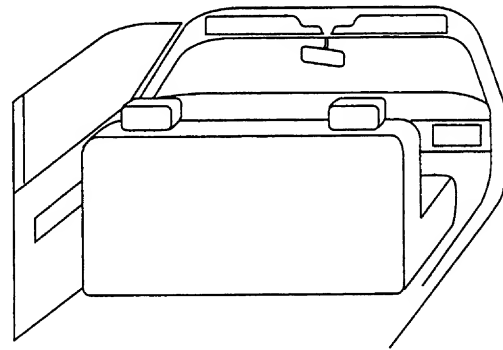
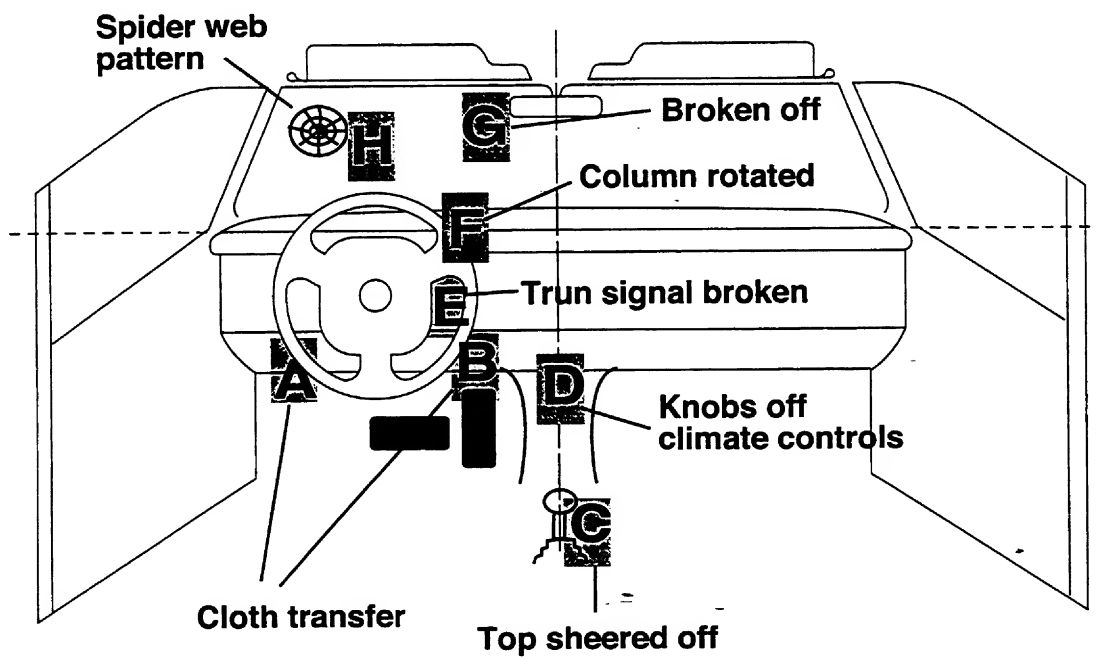
VEHICLE OCCUPANT CONTACT DIAGRAM

Contact	Interior Component Contacted	Occupant No. if Known	Body Region if Known	Supporting Physical Evidence	Confidence Level of Contact Point
A	Knee bolster	1	Head	Cloth transfer	1
B	Knee bolster	1	Head	Cloth transfer	1
C	Shift lever	1	Head	Top sheared off	1
D	Center stack	1	Shoulder	Knobs off climate controls	1
E	Turn signal	1	Chest	Broken	3
F	Steering wheel	1	Chest	Column rotated	3
G	Rearview mirror	1	Head	Broken off	2
H	Windshield	1	Hand	Spider web pattern	1
I					
J

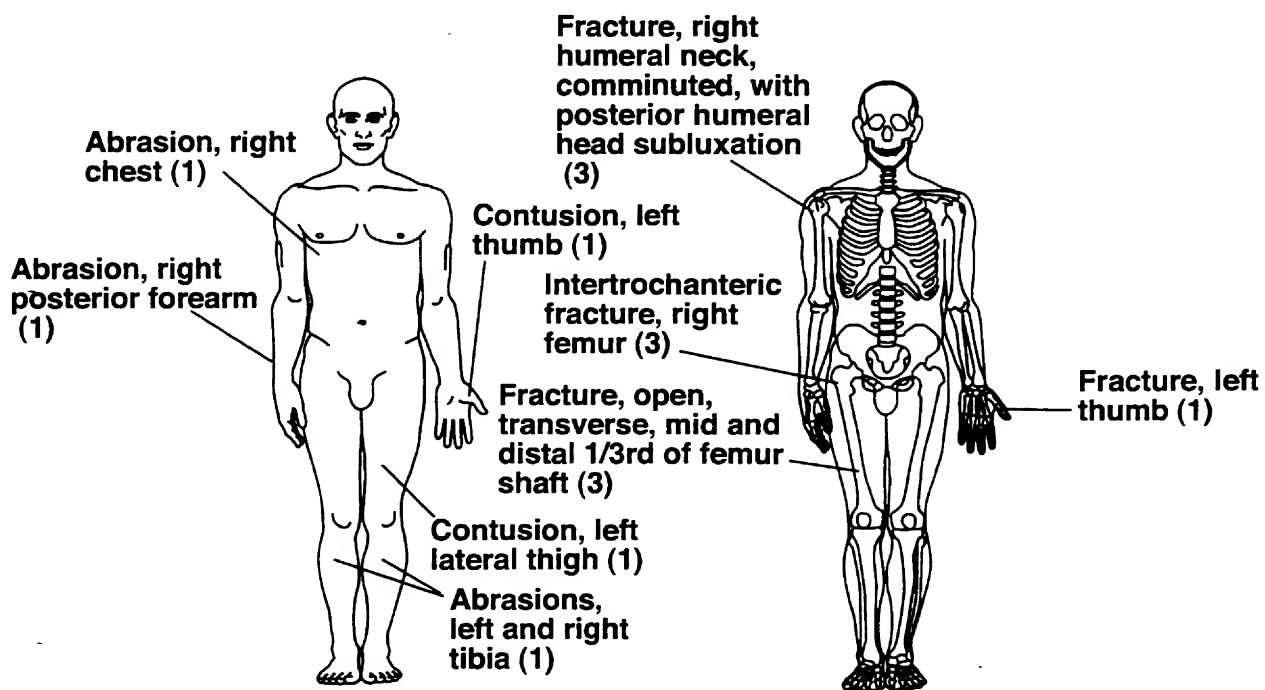
INDICATE LOCATION OF INJURIES.

Injury Description	A.I.S.	Injury Source		
		Definite	Probable	Possible
Fracture, left thumb	1		Steering-wheel rim	Windshield
Contusion, left thumb	1		Steering-wheel rim	Windshield
Abrasion, right side of chest	1		Airbag	Vertical console
Fracture, comminuted, right humeral neck with posterior humeral head subluxation	3		Vertical console	
Abrasion, right posterior forearm	1		Vertical console	
Contusion, left lateral thigh	1		Interior surface of door (during first impact)	
Intertrochanteric fracture, right femur	3		Knee bolster	
Fracture, transverse, open, of the mid and distal 1/3 rd of the right femoral shaft	3		Knee bolster	
Abrasions, left tibia	1		Knee bolster	
Abrasions, right tibia	1		Knee bolster	
<u>Maximum A.I.S. Level</u>	<u>3</u>			
<u>Injury Severity Score</u>	<u>10</u>
